# #719 LONGMEADOW

## ITEM # 305603

Customer:	
Job Name:	
Title:	719 Longmeadow Assembled

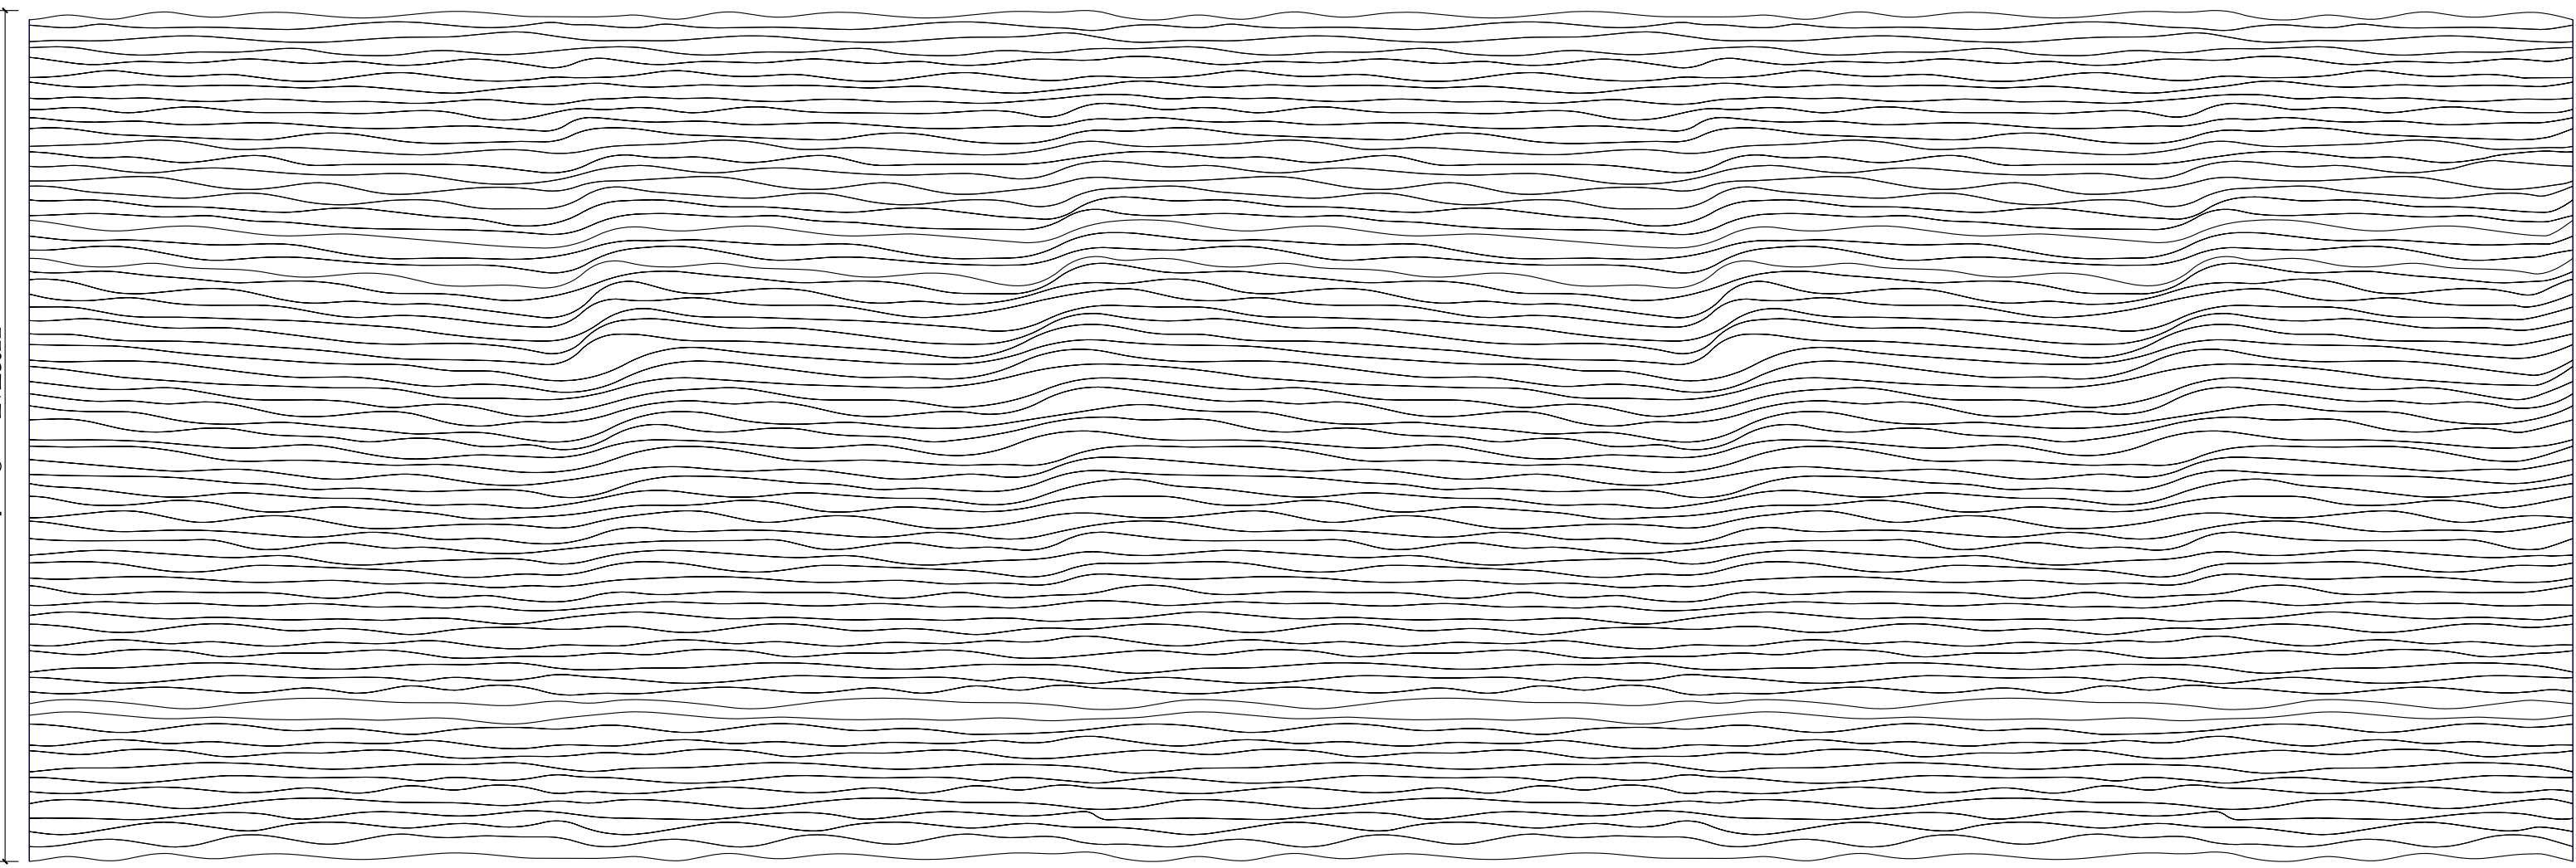
12'-0"

Varies With Pattern  
4'-0" Max

Actual Pattern May Vary

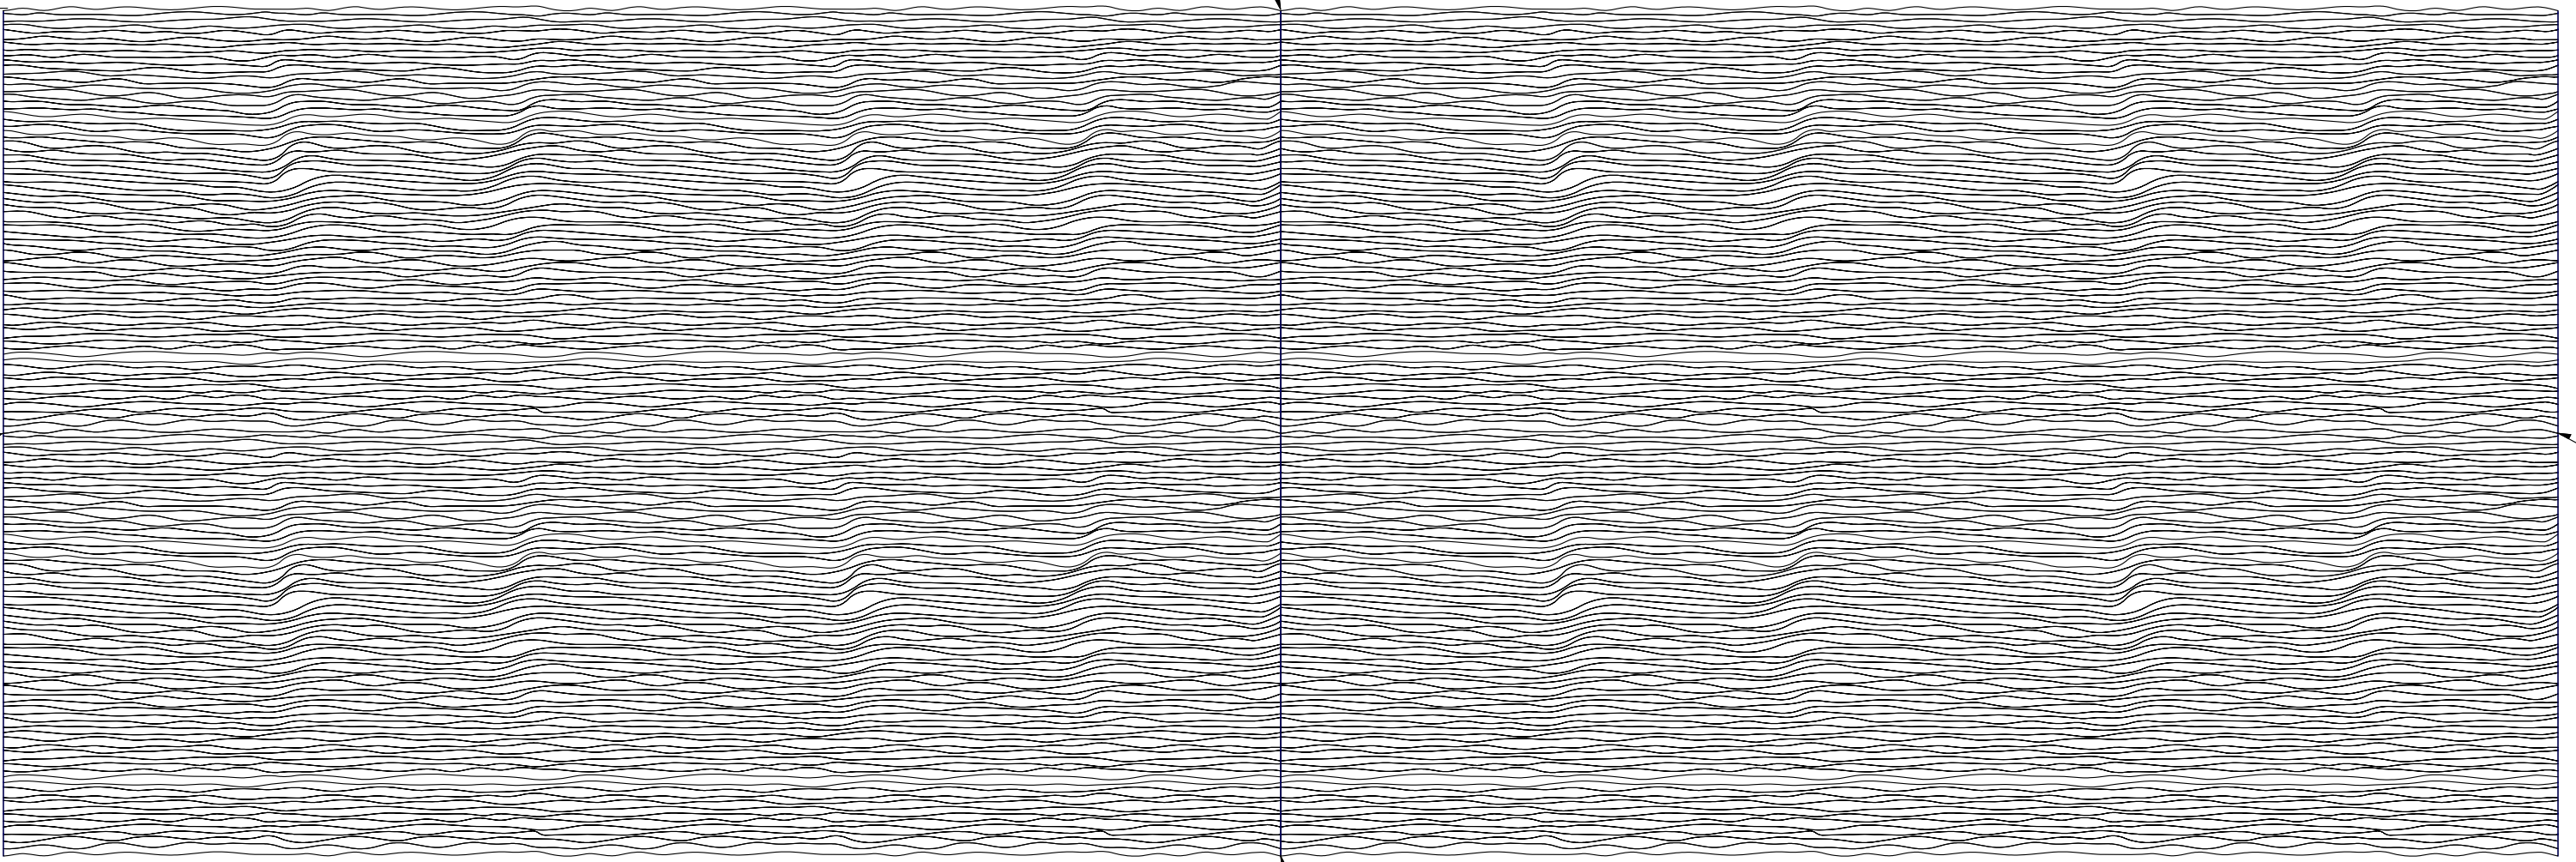
## 24'-0"

Varies With Pattern

### 8'-0" Max

A noticeable seam will occur if not properly sealed when stacking liners.
