ITEM # 306175

Customer:
 Job Name:
 Title: #931 Dry Fit Ashlar

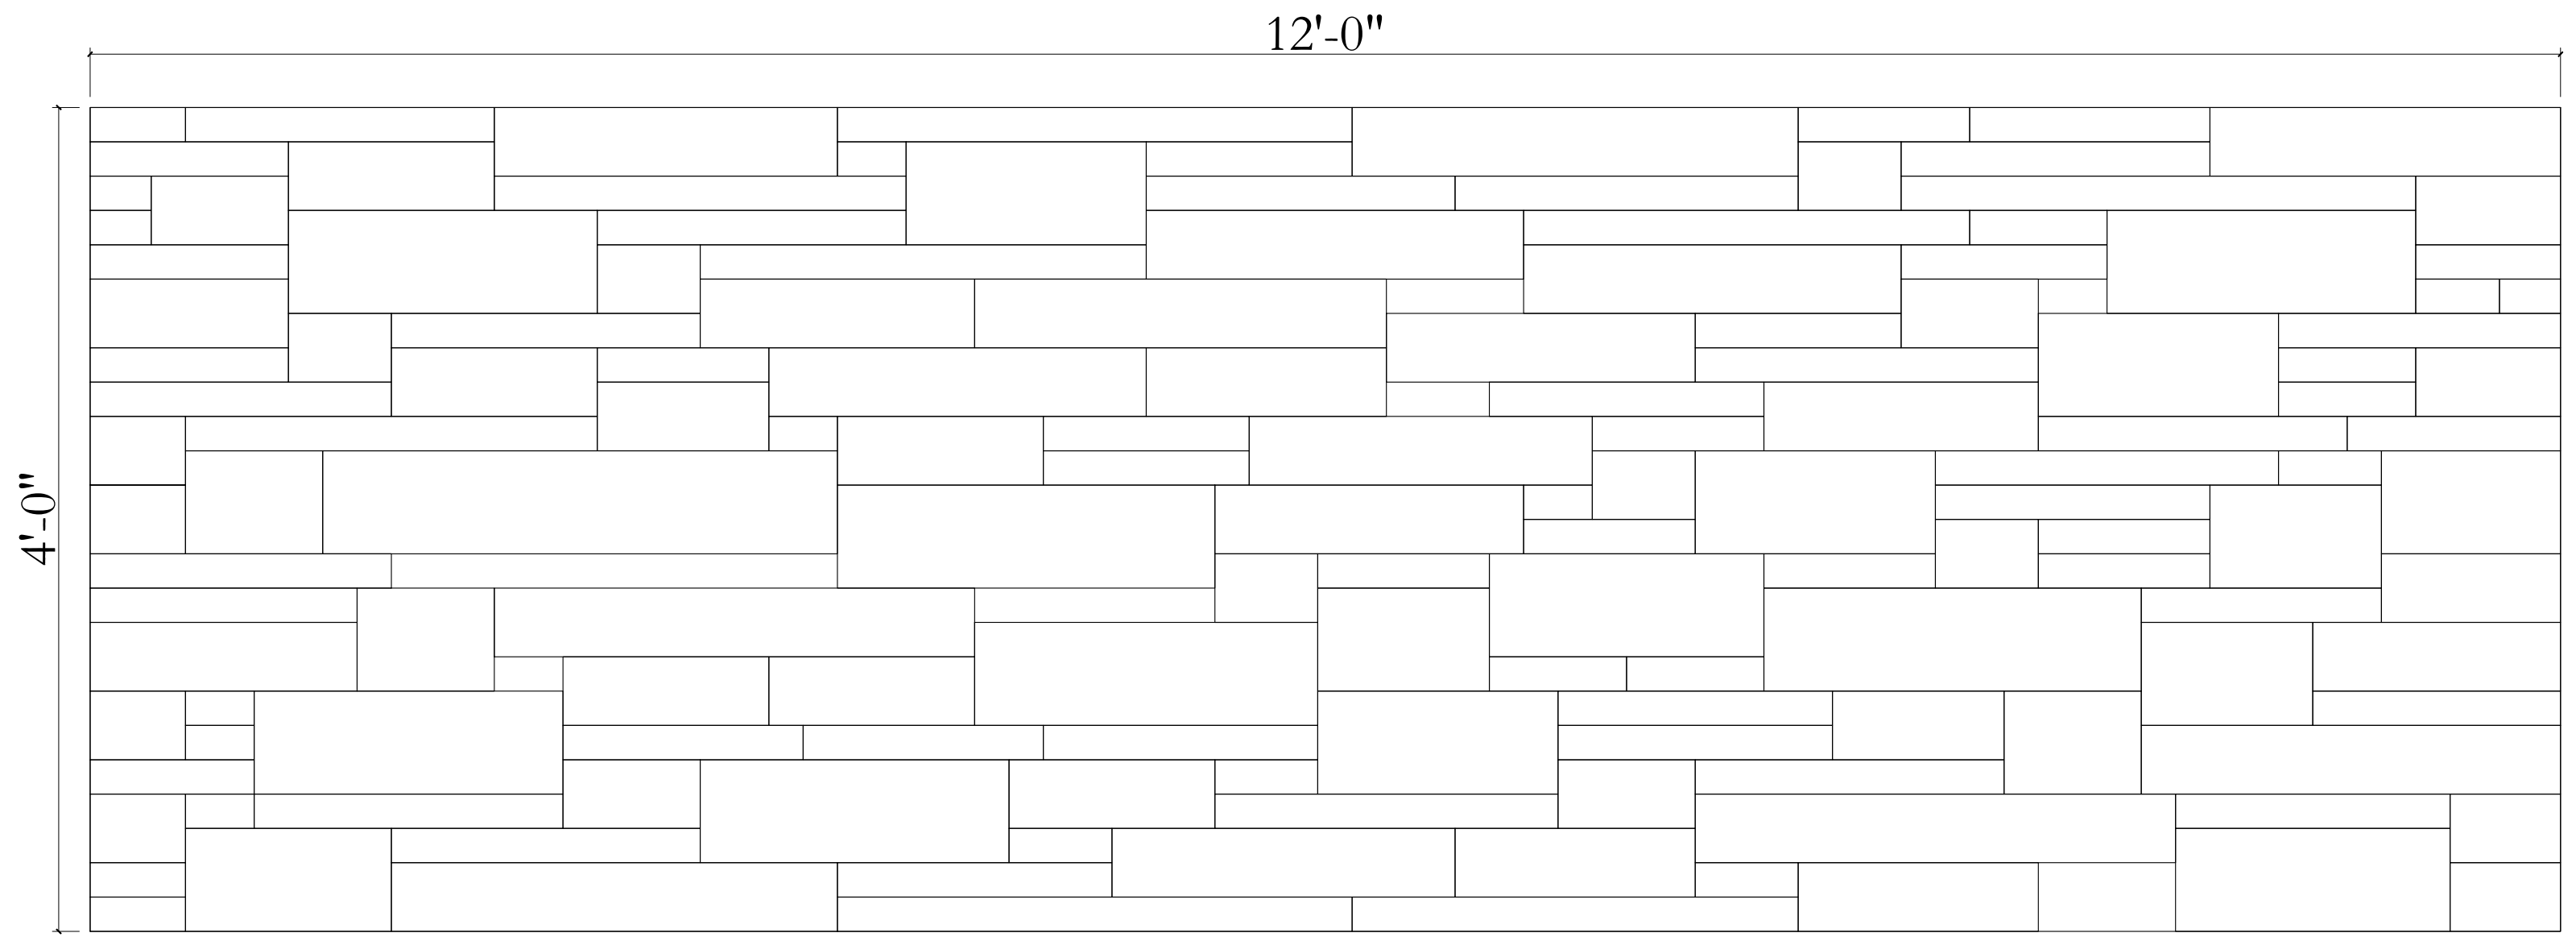
Stone layout for visual reference only, actual stone layout determined by AP

24'-0"

8'-0"

A noticeable seam will occur if not properly sealed when stacking liners.

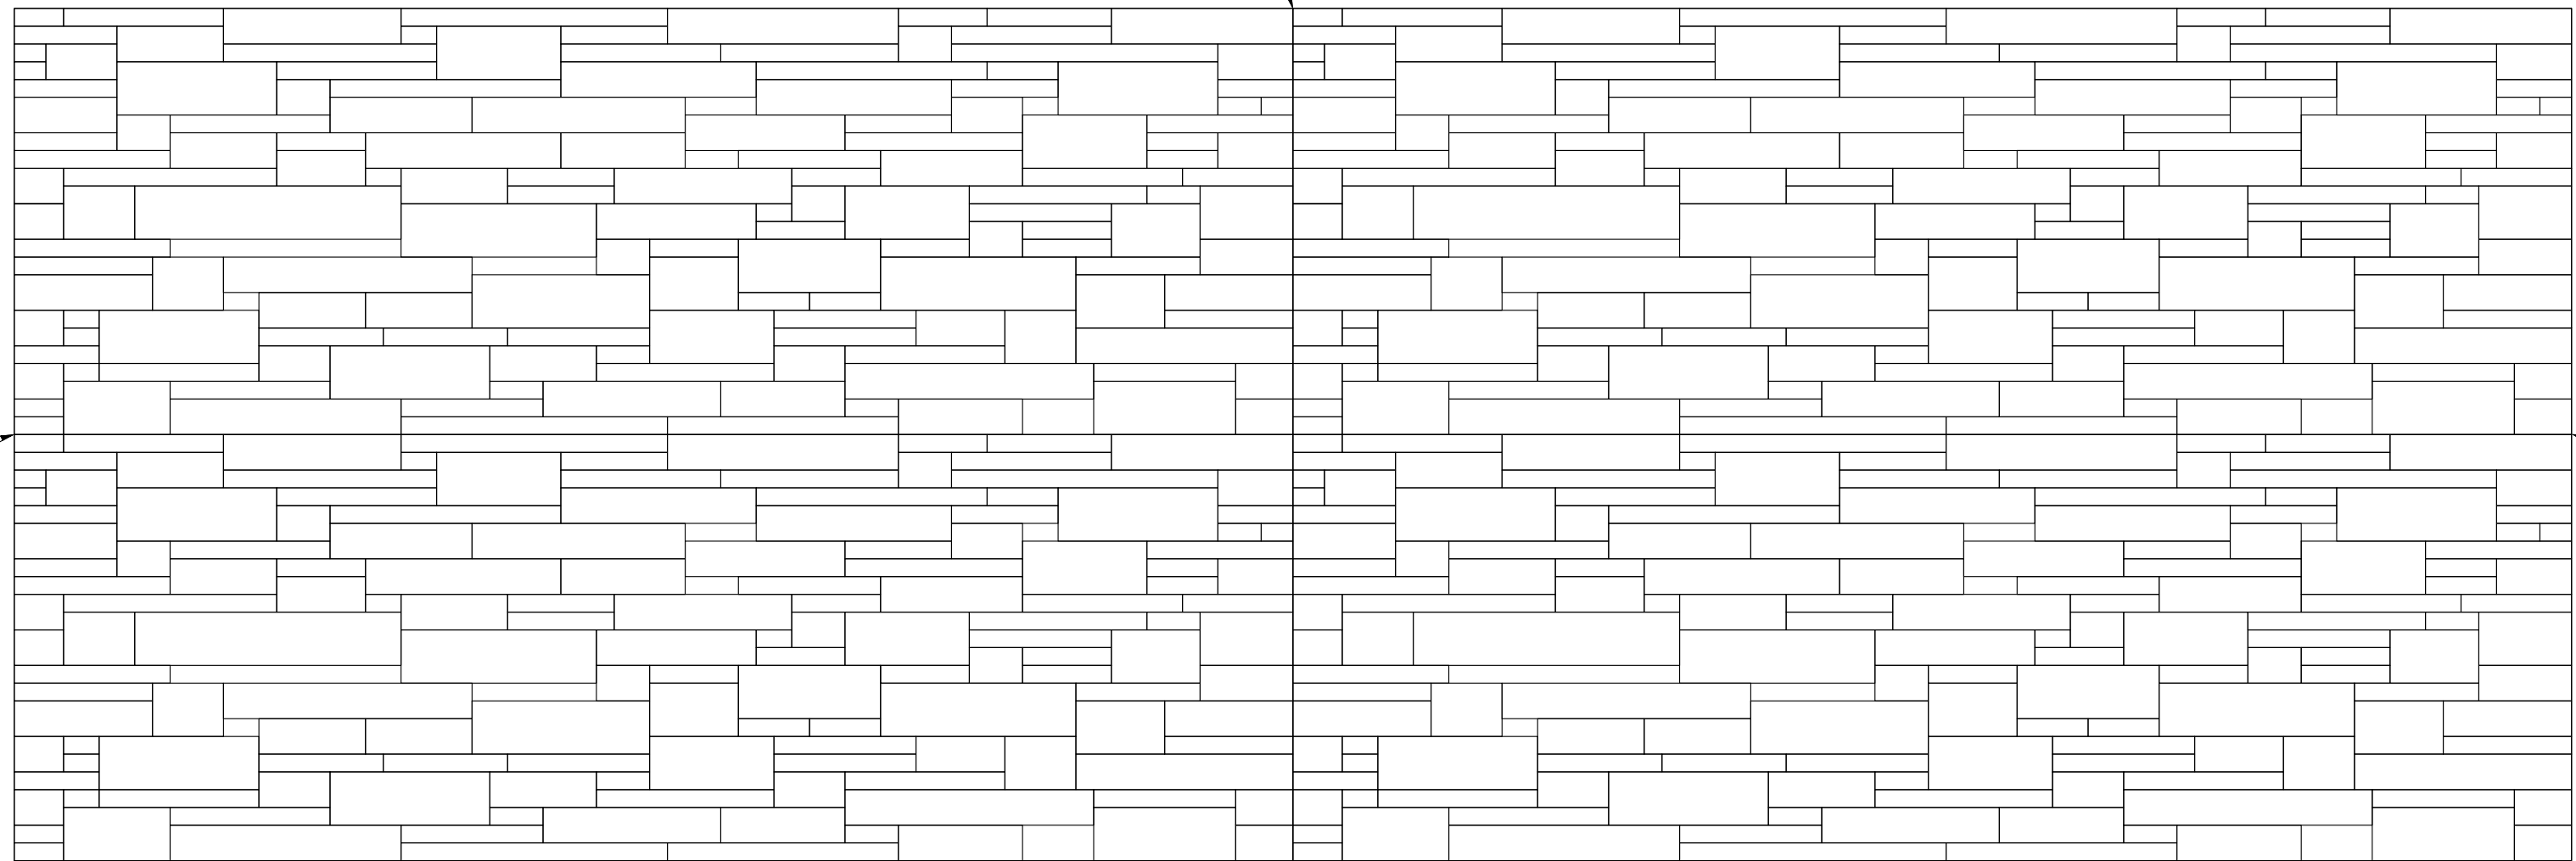
Typical Section

A noticeable seam will occur if not properly sealed when stacking liners.
